ELECTROSONICS BUILDING EVALUATION REPORT

DECEMBER 2023

NHDES
AND THE
TOWN OF CHESTERFIELD
NEW HAMPSHIRE

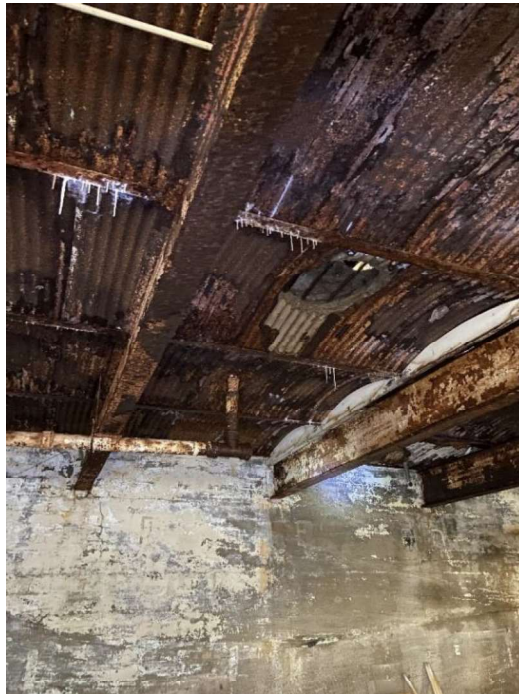
The first floor (street level) is reinforced concrete floor supported by corrugated metal arches. The metal arches are likely formwork and not required structurally after the concrete has attained required strength. The arches span approximately 5 feet and are supported on partially encased steel beams which are then supported by 20-inch-deep steel beams spanning the full width of the building (34 feet) and spaced at roughly 8 feet on center. This layout is depicted in Figure 1 below.

Figure 1 - Steel beams with corrugated metal arches above.

The beams supporting the first floor have a layer of rust with minor section loss. No locations of significant section loss were noted on the main support beams.

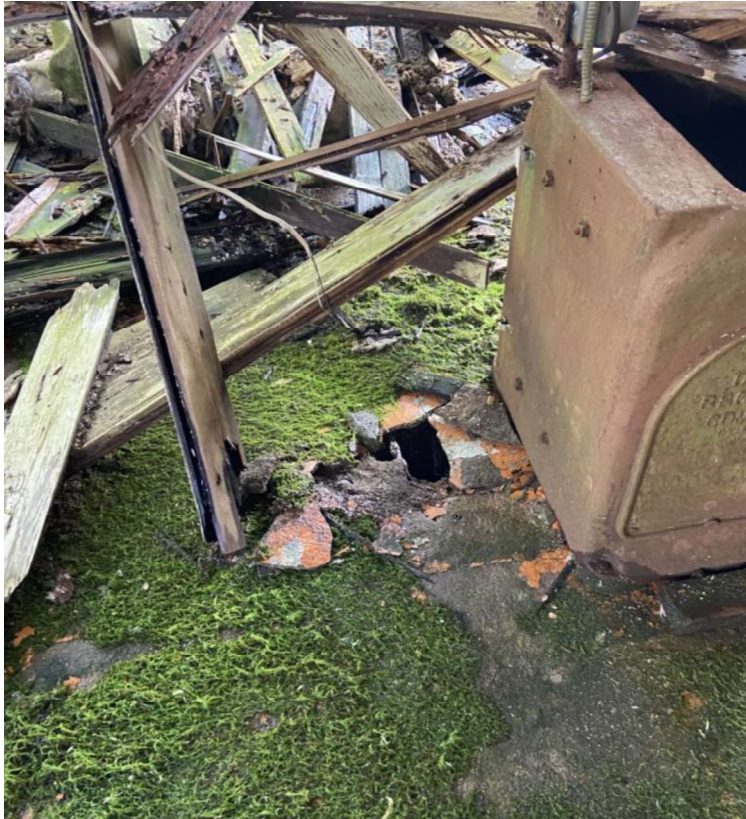
At the first-floor level, exposure from the leaking roof, broken windows and a large hole in the second floor has allowed water to corrode the rebar in the approximately 6-inch thick floor slab as evident in Figure 2 below. The moss growth on the first floor indicates consistent exposure to water throughout the building. Corrosion of the rebar in the slab throughout the first floor is assumed.

Figure 2 – Hole in the slab at the first-floor level.

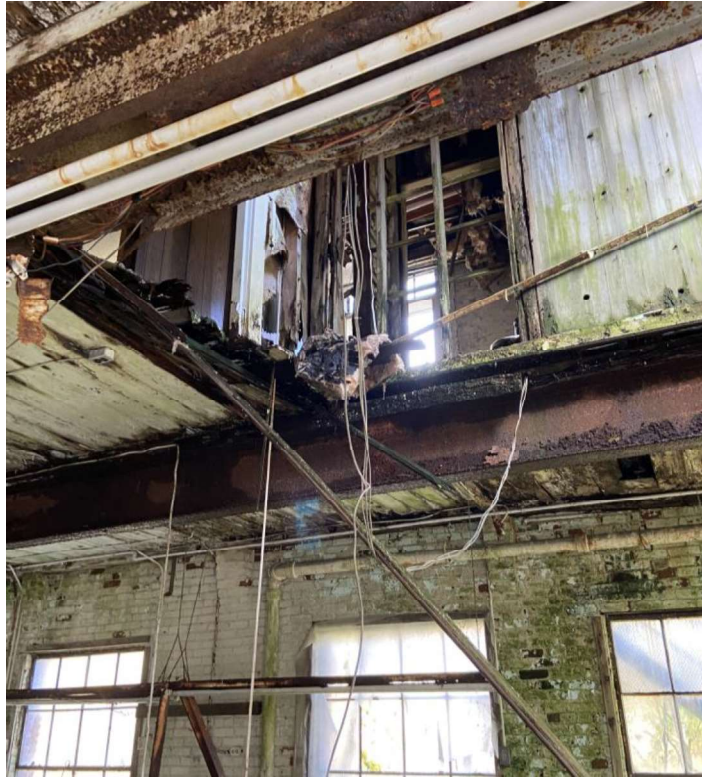
The second-floor framing consists of 3-inch tongue and groove wood plank flooring spanning approximately 8 feet to 15-inch-deep steel beams with a 4-inch-deep wood nailer plate on the top flange. The wooden planks have deflected in areas of high moisture and in some places, have completely caved in. The following figure exhibits the aforementioned issue in the northeast corner of the Site.

Figure 3 - Floor cave-in between steel beams looking up at the second floor above.

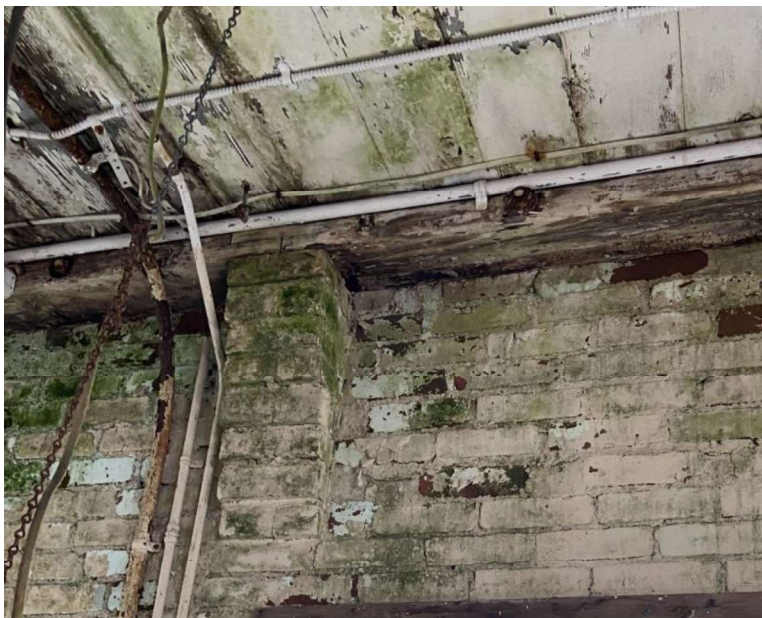
A 4-inch by 6-inch wood beam spans along the perimeter of the building to support the wooden floor planks above. At the rear of the building, the 4-inch by 6-inch beam is supported on brick corbels and is tied into the brick masonry with through-bolts. The front of the building does not have brick corbels. Figure 4 shows the configuration at the back of the building.

Figure 4 - 4" x 6" beam resting on a corbel.

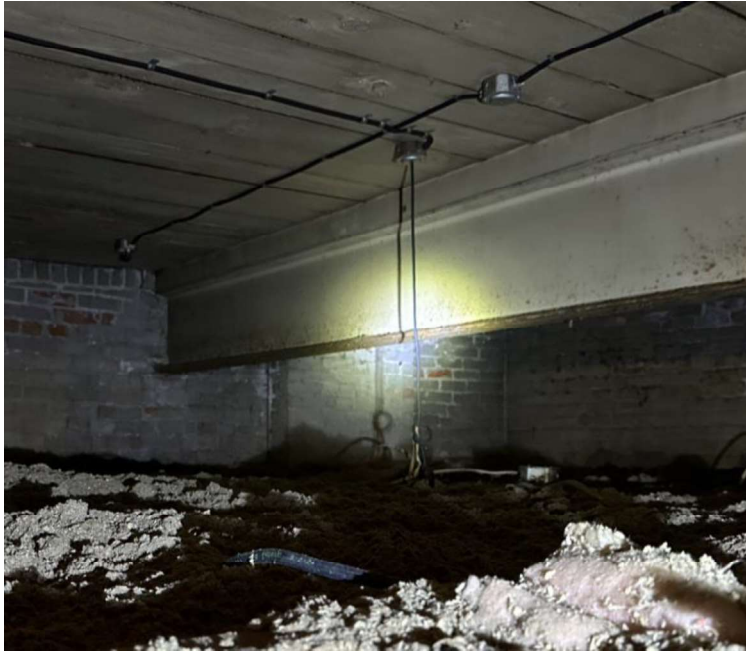
The roof framing appears to be the same layout as the floor below with 15-inch-deep steel beams, a 4-inch wood sill beam on top, and wooden planks above. The figure below shows this configuration and the building's drop ceiling. Weston & Sampson did not access the roof during the structural assessment due to the observed holes and assumed deterioration.

Figure 5 - Roof framing.

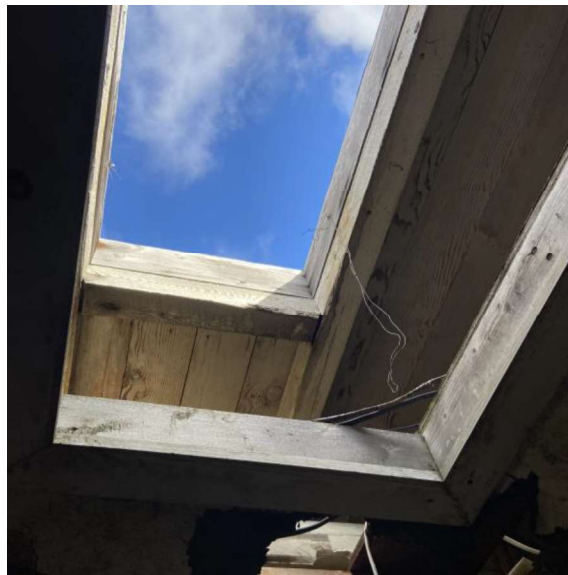
The photo below was taken from the top of the stairs leading to the second floor. The hatch was found open to the roof, exposing interior building elements to weather. The flooring below this opening was spongy and likely deteriorated due to prolonged exposure to precipitation and moisture.

Figure 6 - Roof hatch adjacent to the top of stair at second floor.

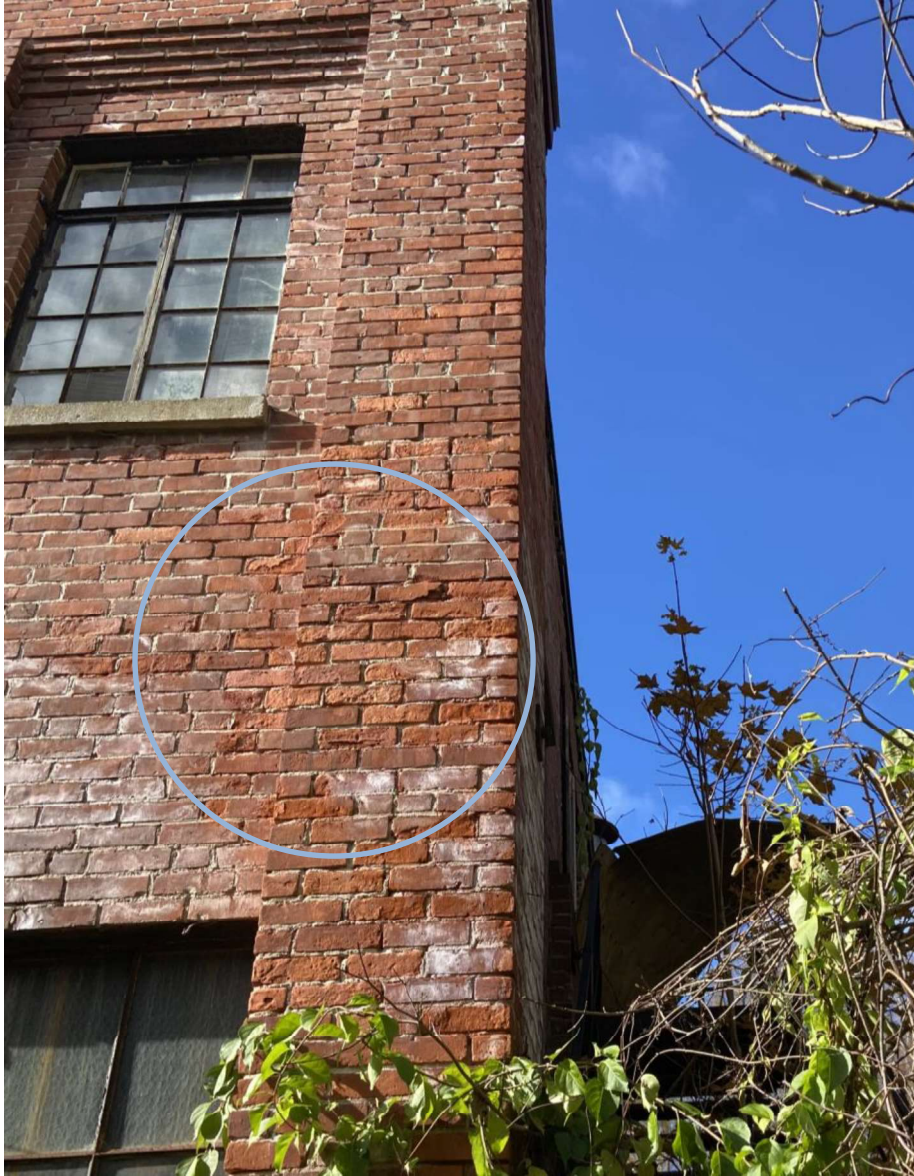
The masonry walls were measured to be 12 inches thick with 16-inch-thick pilasters. Brick deterioration was observed by visual inspection. Continuous cycles of freeze-thaw have caused brick faces to pop off. The photos below, taken at the northeast corner of the building and west elevation respectively, highlight areas where this was observed.

Figure 7 - Brick deterioration at the NE corner.

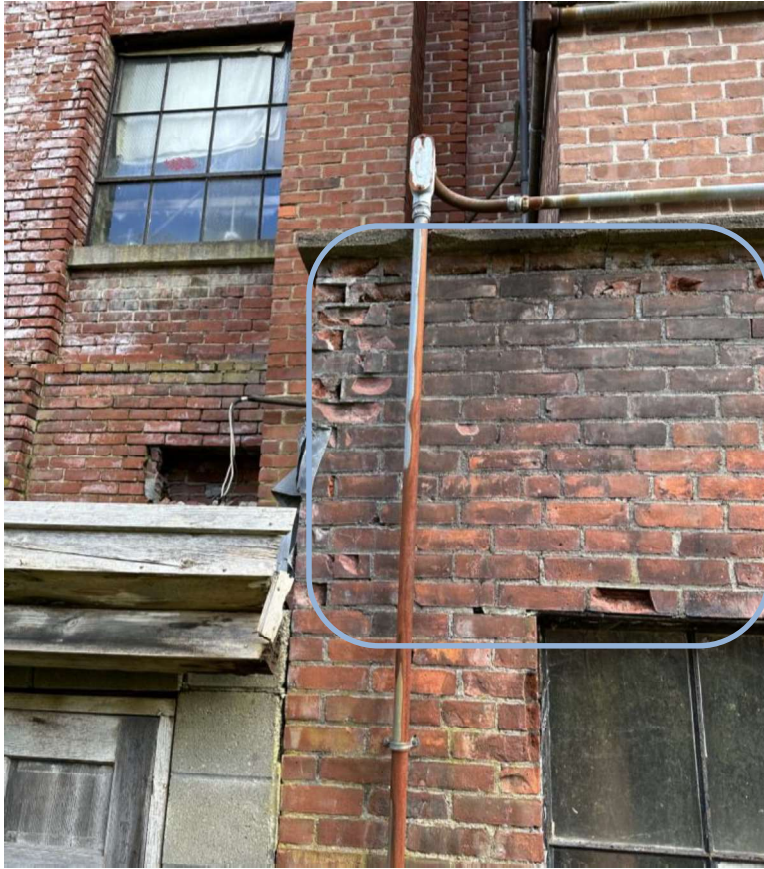
Figure 8 - Brick deterioration at the western face.

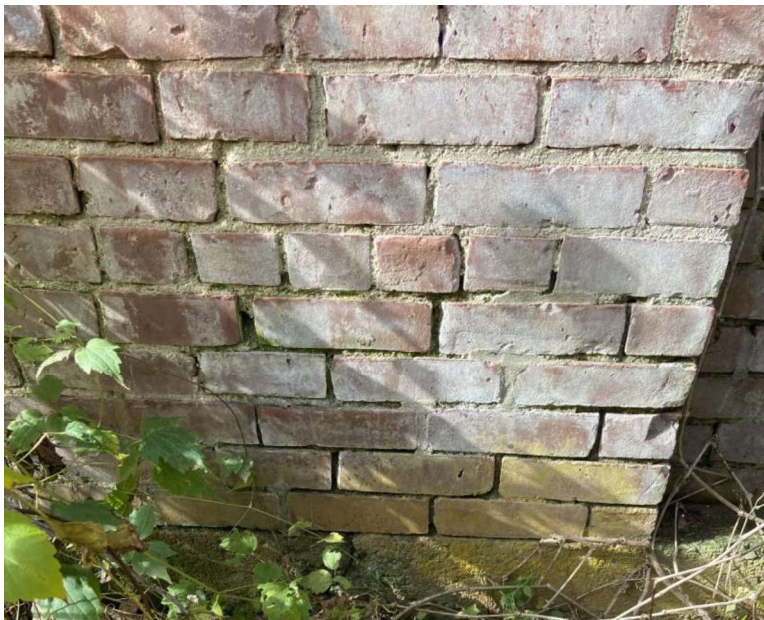
Mortar loss and efflorescence were observed in multiple areas of the building. The following figure represents one of these instances.

Figure 9 - Mortar loss and brick efflorescence.

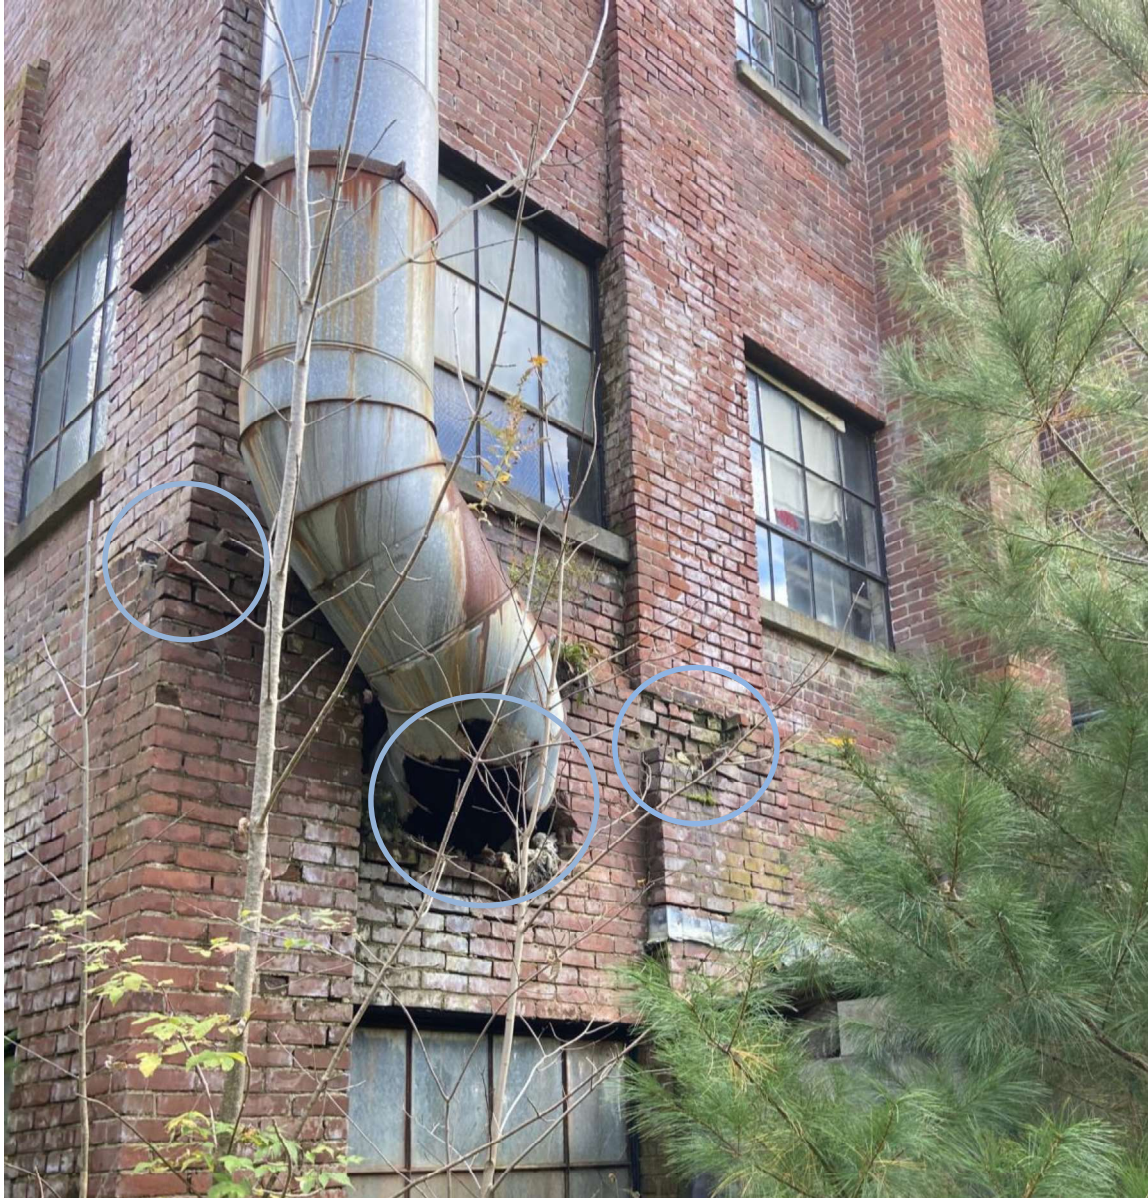
A few sections of the building are missing bricks. The northwest corner of the building, shown in the figure below, is missing bricks from the pilasters and around the vent pipe. The chimney shown in the right-most edge of Figure 10, and more clearly shown in Figure 11, is missing bricks from the top of the structure. See Figure 16 for a top view of the chimney deterioration.

Figure 10 - Missing bricks at the NW corner.

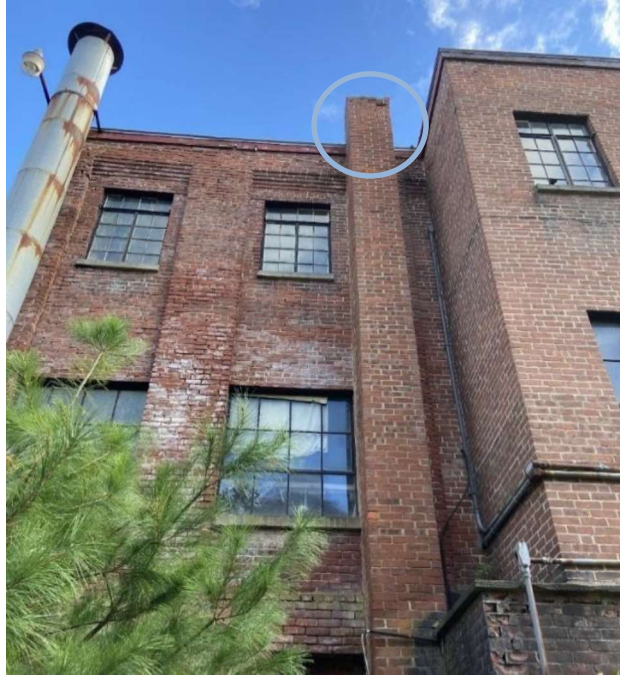
Figure 11 - Bricks missing from the chimney.

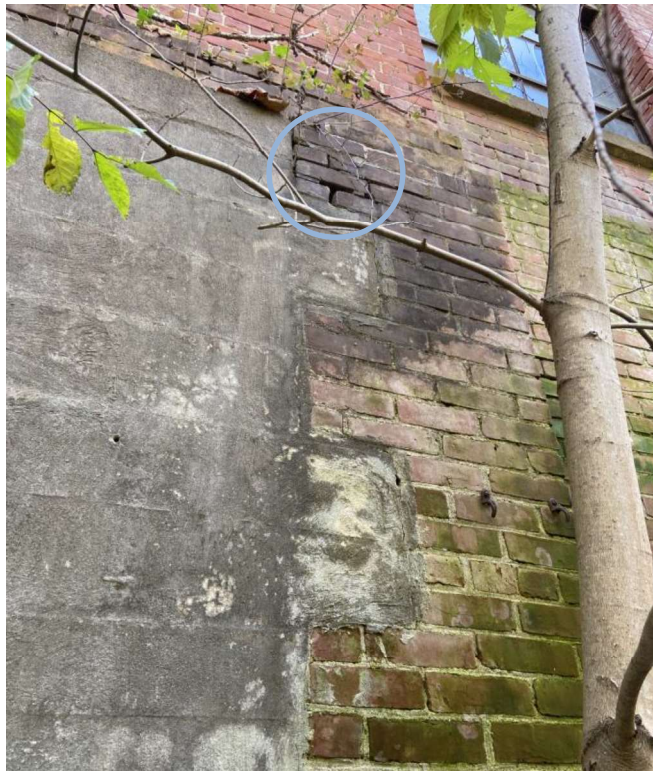
At the north side of the building, the exterior masonry wall appears to have been patched with concrete. The brick in this area shows green and brown moss staining associated with moisture trapped by vegetation. Mortar loss is evident in this area, as shown in the following figure.

Figure 12 - Stained bricks and mortar loss at the back of the building.

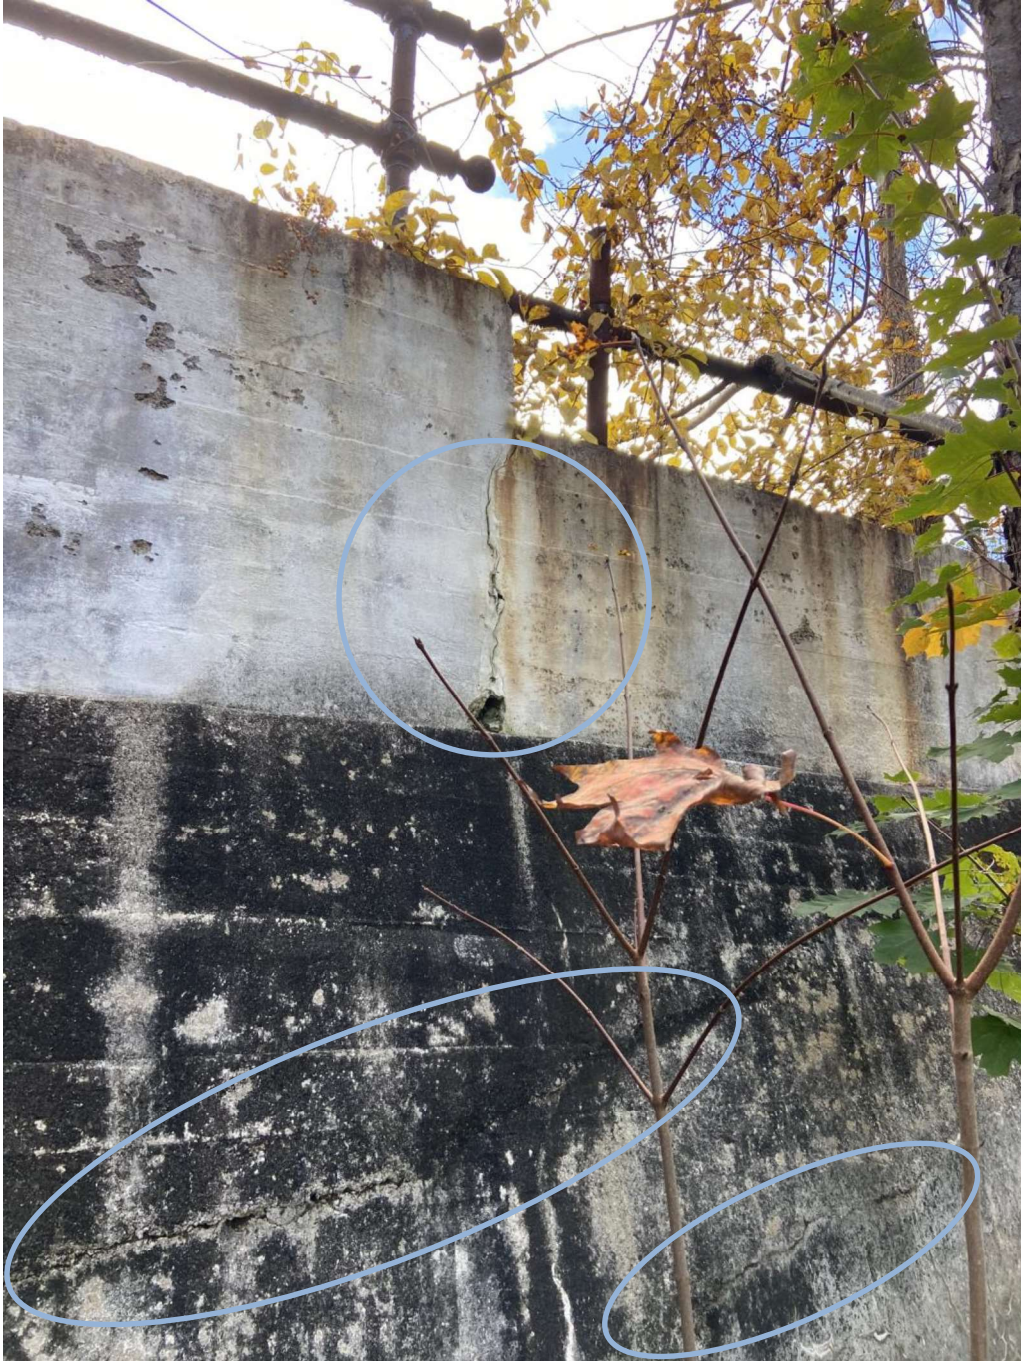
The retaining wall on the western side of the building separating the parking area from the side entrance has visible vertical and longitudinal cracking. The figure below shows a vertical crack where the retaining wall steps down.

Figure 13 - Cracking in the concrete retaining wall.

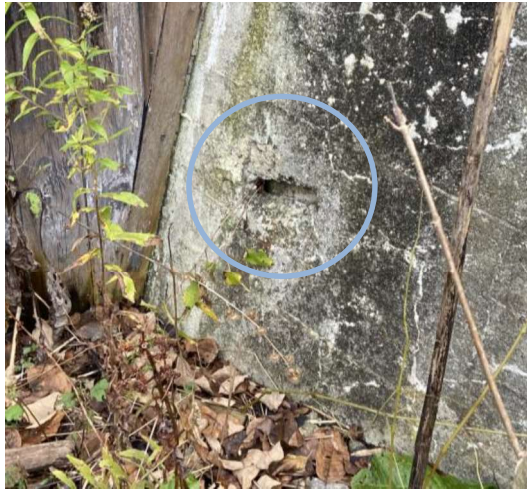
At the corner where the retaining wall meets the southeastern corner of the building, a chunk of concrete has popped away exposing a steel reinforcing bar beneath. This deficiency is called out in Figure 14.

Figure 14 - Exposed steel reinforcing in the retaining wall.

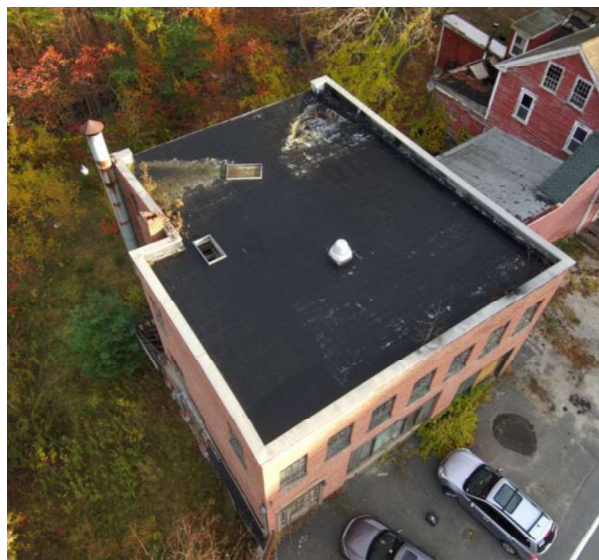
A drone captured images of the roof at the Site. The two primary areas of interest are the northeast and northwest corners at the rear of the building. Review of the photos indicates that water has pooled in these areas and seeped through the roof membrane causing deterioration of the levels below. The hatch noted in Figure 6 is seen from above in the drone photos. Figure 15 shows standing water in the northwestern corner of the building in addition to the hatch and a wooden box, which may have once been the cover to the hatch. The drone photos did not suggest significant roof deterioration at the southern, or street facing, side of the building which is consistent with what the evaluation team observed within the building. The southern side of the building showed minimal evidence of moisture or rot above the basement level.

Figure 15 - The roof of the building from drone view.

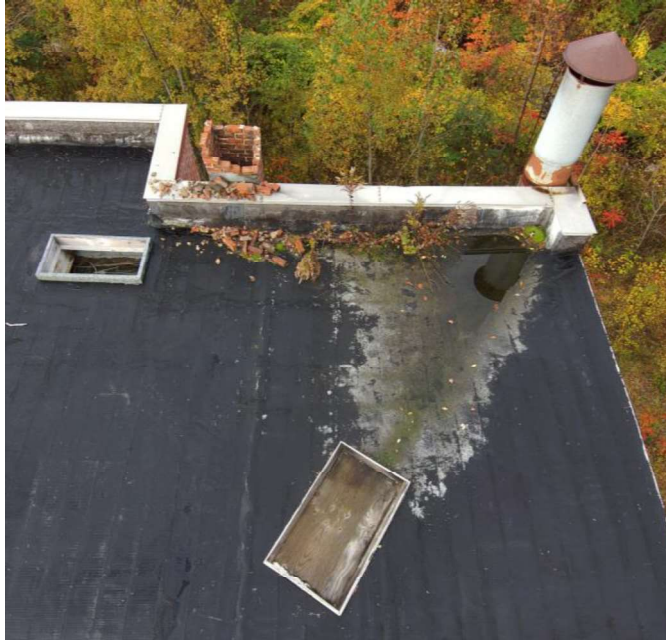
The figure below shows a closer view of the northwestern corner of the building. The hatch and potential cover are visible, as well as the deteriorated chimney referenced in Figure 11 with bricks scattered behind the parapet wall. The circle of green moss growing in the rightmost corner of the parapet wall suggests that the roof drain is clogged which has led to water pooling on the roof.

Figure 16 - NW corner of the roof.

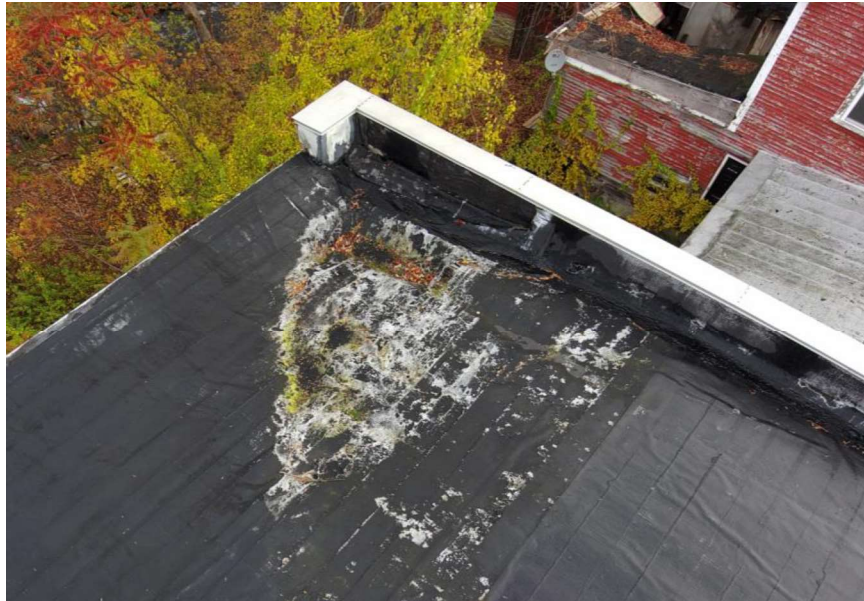
Figure 17 shows a closer view of the northeastern corner of the roof. Sagging of the roof framing is evident in the photo.

Figure 17 - NE corner of the roof.
